STRUCTURAL PERFORMANCE OF MANGROVE REINFORCED CONCRETE BEAMS

ABSTRACT

KEYWORDS: Mangrove Reinforcement, Tensile Strength, Flexural Strength, Deflection

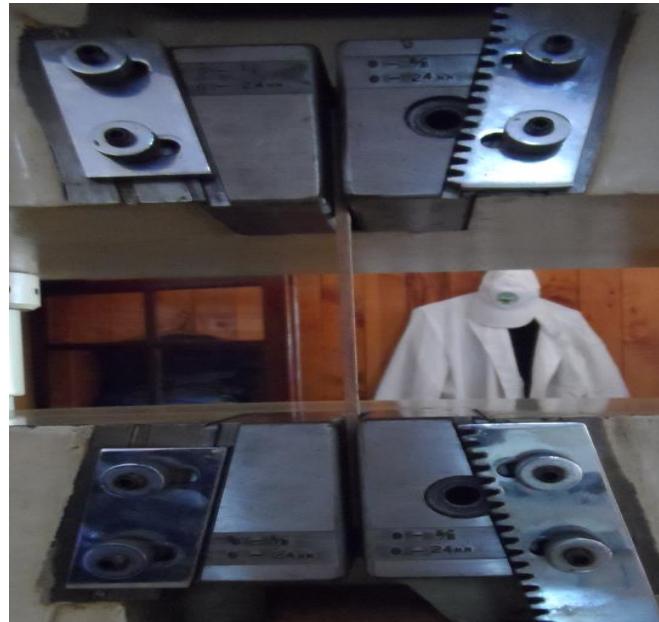
Figure 2: Tension Parallel to Grain test of Mangrove

The resistance to tension of mangrove was determined parallel to the grain. The test piece was so orientated that the direction of the annual rings at the cuboidal section was perpendicular to the greater cross-sectional dimensions. Actual dimensions at the minimum cross-section were measured. The load was applied to the 2 cm face of the ends of the test piece by special toothed plate grips which were forced into the wood before the test piece commenced as shown in Figure 2. These grips were designed so as to give axial load. The load was applied to the test piece at a constant head speed of 0.05 in./min.

During these tensile tests, all tensile specimens' failure occurred near the edge prepared for the grip. The stresses of the mangrove specimens found are quite different from one another since mangrove is a natural material and the defects (knot size, slope, splits, etc) that they have in them vary from one another. Taking the defects into account, average stress has been reduced by a safety factor of 0.8 which is the coefficient of safety of wood as provided for in BS 5268 [8] to obtain the characteristic tensile strength approximately equal to 153 N/mm^2 . It is noted that the tensile strength of mangrove as compared with that is approximately three times less than that of steel. None the less, its usage may still be applicable particularly where loadings regimes can be accommodated within the mangrove strength.

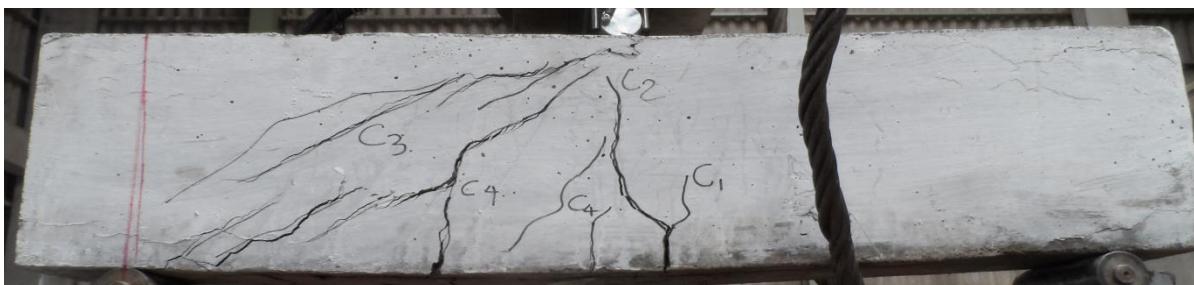
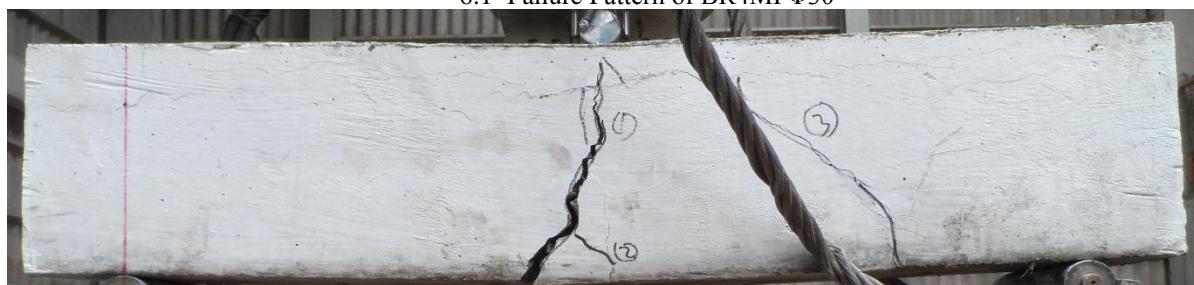
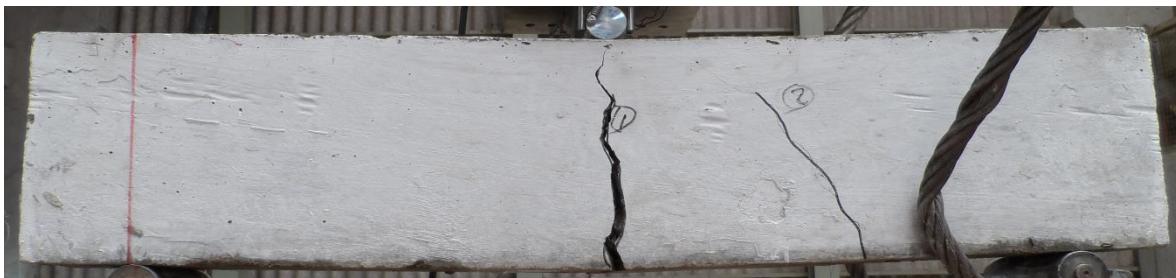
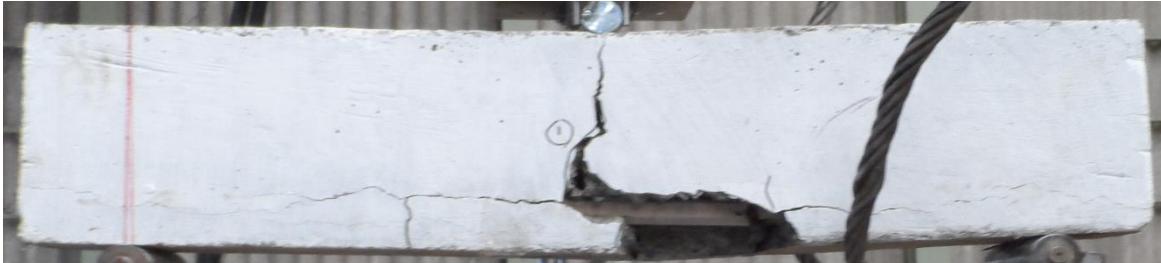
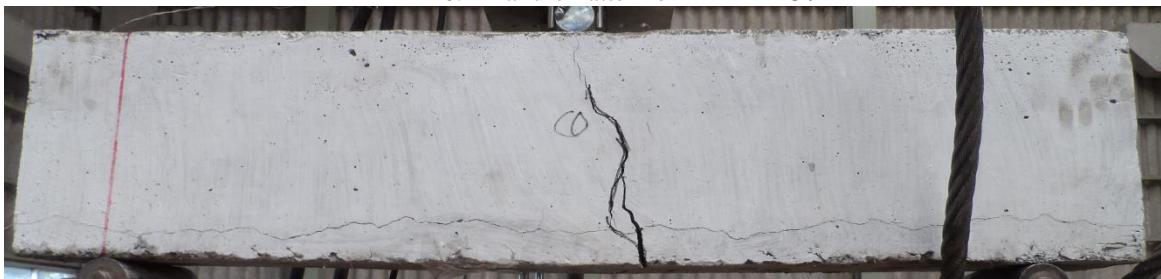
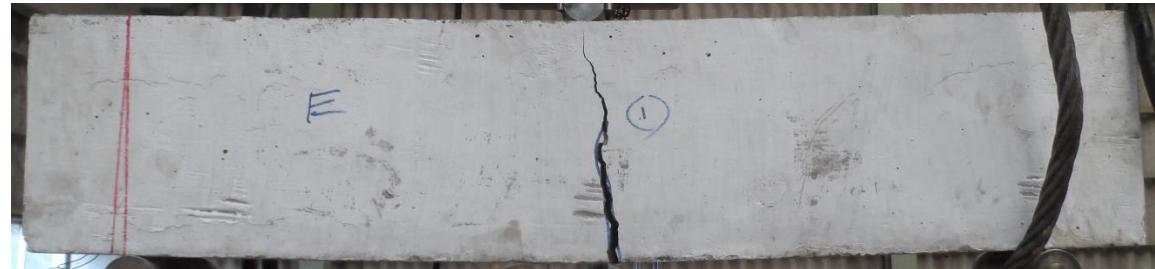
Figure 6: Failure Pattern of Beams

6.1 Failure Pattern of BR4MPΦ30

6.2 Failure Pattern of BR4MPΦ25

6.3 Failure Pattern of BR4MPΦ20

6.4 Failure Pattern of BR2MPΦ30

6.5 Failure Pattern of BR4MPΦ25

6.6 Failure Mode of BR4MPΦ20

The test results from Table 2 shows that the beams with 7.80% mangrove reinforcement ratio (BR4MPΦ30) failed in flexure accompanied by more shear cracks near the support on the left side as seen in Figure 6.1. This could be as a result of a higher reinforcement ratio and thus ability to carry more load than the other beams including the control beams. Beams BR4MPΦ25 and BR4MPΦ20 failed in bending accompanied by one shear crack near the support on the right side as shown in Figure 6.2 and 3 respectively. These two beams (BR4MPΦ25 and BR4MPΦ20) had almost the same failure mode; the only difference is that the first bending crack of BR4MPΦ25 did not occur exactly at the center of the beam but a bit more to the left giving way to a second crack opposing it to the right near the center as well (see Figure 6.2). While the first crack of BR4MPΦ20 occurred at the center of the beam and vertically from the bottom to the top as shown in Figure 6.3, BR2MPΦ30 failed in bending by a central vertical crack accompanied by small cracks both on the left and right side of the beam as shown in Figure 6.4. It is noted in Figure 6.4 that a piece of concrete fell out from the lower section of the beam, revealing a nearly perfect imprint of the mangrove reinforcement. This suggested a poor bonding between the concrete and mangrove, leading to bond failure. Upon examining the beam at the region of failure crack (Figure 8) the mangrove pole in tension seemed to be broken, leading to the assumption that the beam failed in due to existence of Knot defect. However, failure

pattern of BR2MPΦ25 and BR2MPΦ20 are similar, both of them failed in bending by only one vertical crack more or less at the center from the bottom to the top of the beam. While BR4SBΦ10 failed in bending with high ductility. During test, two vertical cracks occurred on BR4SBΦ10 equidistant from each other from the center as shown in Figure 7.

- (d) It is also determined that the sizes and the number of cracks vary according the sizes of the reinforcements or reinforcement ratio: the bigger the reinforcement ratio of the mangrove poles the bigger and numerous the cracks appeared on the beam, the smaller the reinforcement ratio of the mangrove poles the lesser and smaller the cracks appeared on the beam.
