## STRUCTURAL PERFORMANCE OF SHORT MANGROVE REINFORCED CONCRETE COLUMNS

K.A. Kerté<sup>1</sup>, R. A. Shuaibu<sup>1</sup>, T.Nyomboi<sup>2</sup> and W. O. Oyawa<sup>3</sup>

### ABSTRACT

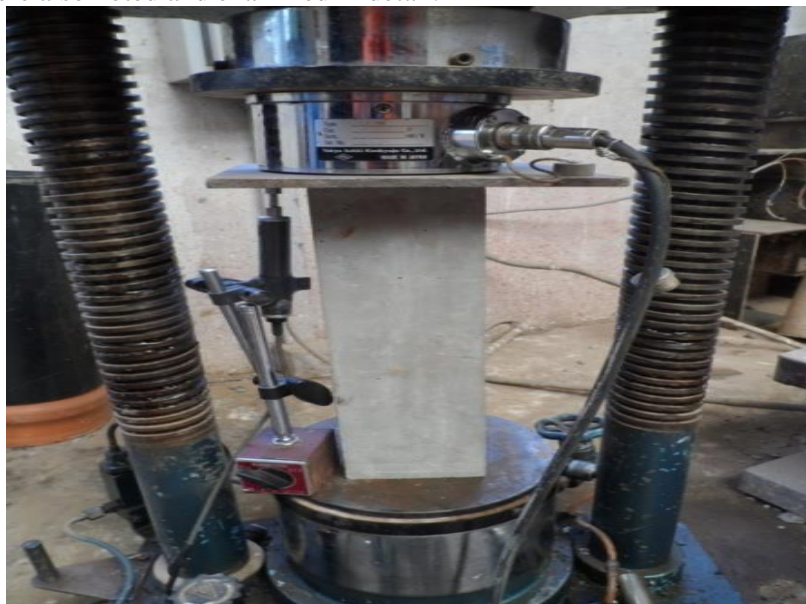
Figure 2: Test set-up of column specimen subjected to axial load

28 days compressive strength tests were carried out on the specimens (cylinders and columns). The column specimen was set up on the Universal Testing Machine, and steel bearing plates were put at the top end of specimen as shown in Figure 2. Axial deformation of the column was measured using a displacement transducer attached to a magnetic base frame. After set up was complete, axial compressive force was gradually applied to specimen using a load cell of 50 tones capacity until failure. Column behavior was observed throughout the loading process and the values of deflection corresponding to the applied gradual loading at an interval of 5kN were recorded. Crack pattern and failure modes were also noted and examined in detail.

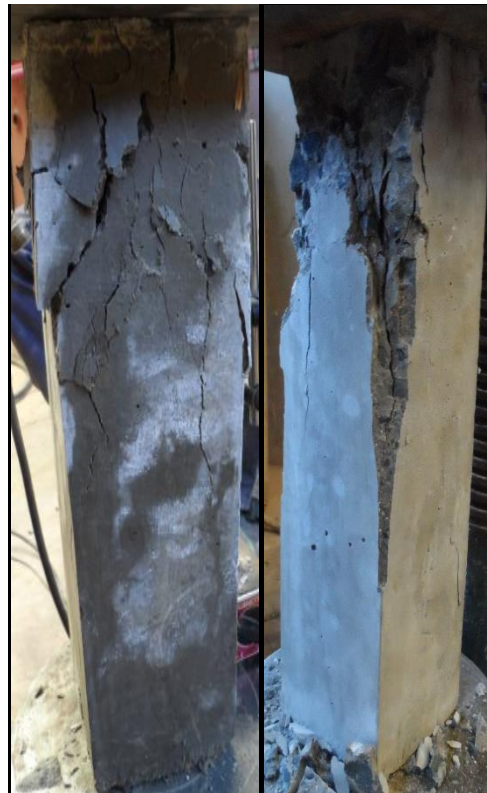
Figure 4: Failure Mode of Control Columns

(a) CR4SB $\Phi$ 8; (b) PCC.

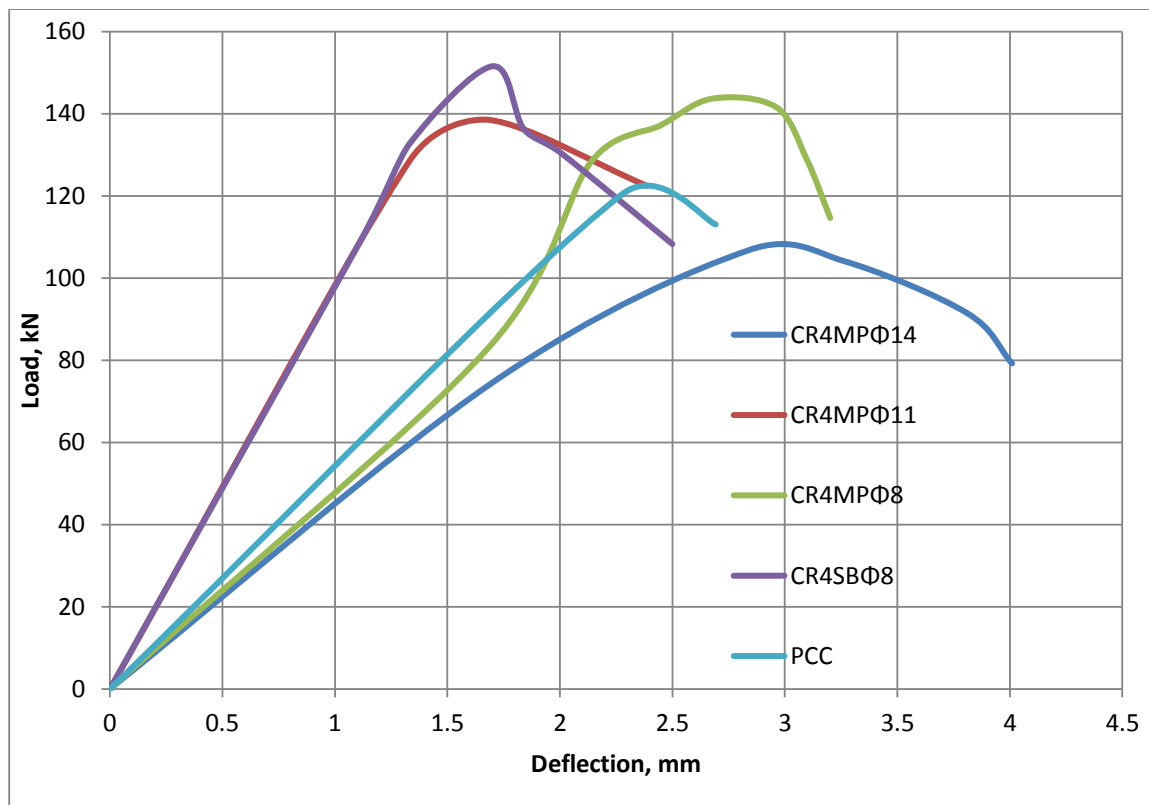
Figure 5: Load-Deflection Curves of Columns Reinforced with Four Mangroves

Figure 5 and 6 show the load-deflection curves of columns reinforced with four mangrove and single central mangrove poles respectively. The load carrying capacity of the steel reinforced was higher, which is noted to be approximately 152kN (Figure 5: CR4SB $\Phi$ 8), while that of the four pole mangrove reinforced columns, apparently was lower with the highest being 138kN (CR4MP $\Phi$ 11) and lowest being 104kN (CR24SCMP $\Phi$ 14). Same trend was noted in the single centrally reinforced mangrove reinforced column where the highest load is 137kN (CRSCMP $\Phi$ 20) against a lower value of 106 kN (CRSCMP $\Phi$ 24). The trend confirms a decreasing load carrying capacity with increasing mangrove reinforcement ratio. Conversely, it was noted that ductility is determined by the position of the mangrove poles and reinforcement ratio in the column. Four mangrove reinforced columns (Figure 5: CR4MP $\Phi$ 8, 11, 14) shows generally higher displacement values as compared to that of single central mangrove reinforced columns (Figure 6: CRSCMP $\Phi$ 16, 20, 24). Although unreinforced concrete column showed also remarkable compressive load carrying capacity, none the less, the usage of the columns reinforced with mangrove showed better resistance than the plain concrete columns because of their ductility behavior. In any case, mangrove can only be applied where loadings regimes can be accommodated within the mangrove strength.
