International Journal of Engineering Sciences & Emerging Technologies, May 2017.
ISSN: 22316604 Volume 9, Issue 5, pp: 139-152 ©IJESET

FAILURE INVESTIGATION FOR INPUT SHAFT OF AUXILIARY HOIST GEAR BOX

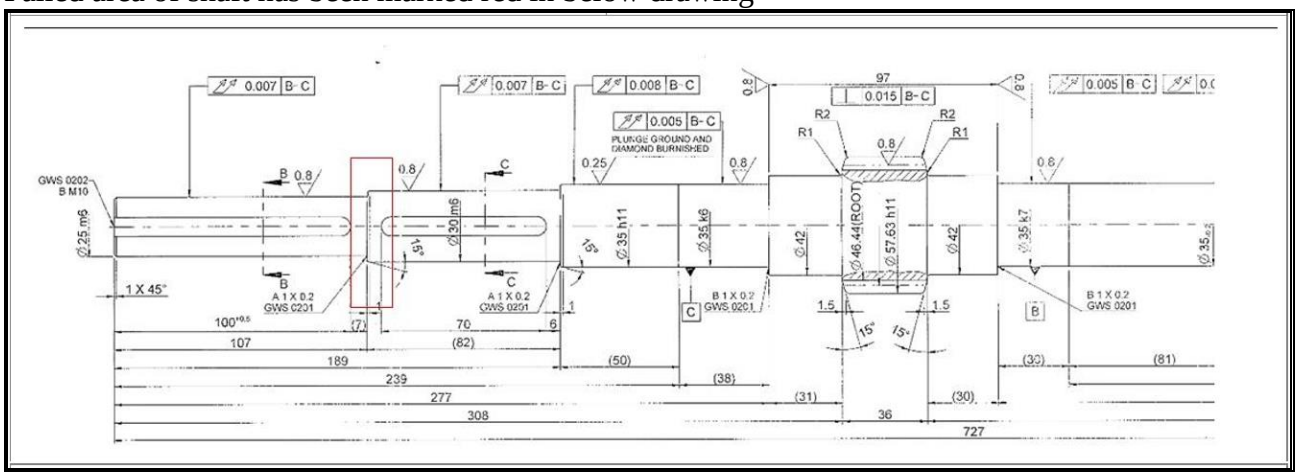
Failed area of shaft has been marked red in below drawing

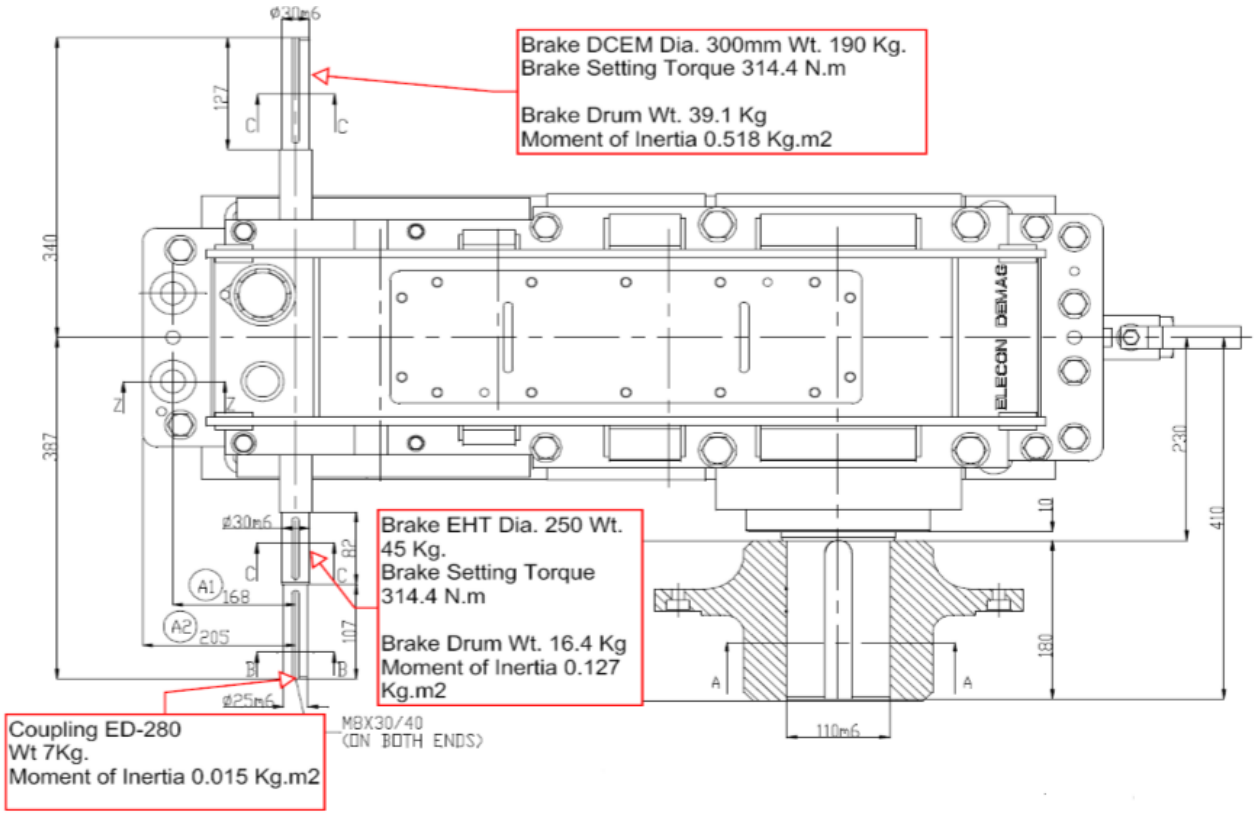
The manufacturing route of shaft is as mentioned: forging – turning – hobbing – heat treatment – teeth grinding – OD grinding. The heat treatment is carried out as per shaft drawing. The gear box is driven by motor and there is thruster brake between gear box and motor. Failure took place between brake and motor. Geared coupling is used between motor and brake.

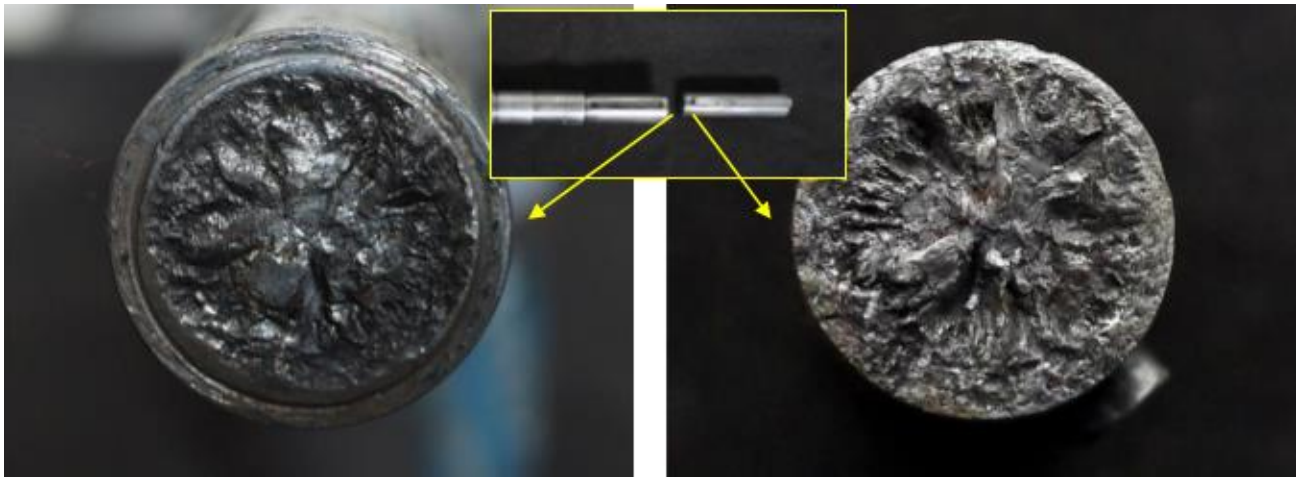
Plate 1 Shows broken piece of input shaft of hoist gear box in as-received condition. The fracture region is in the marking area.

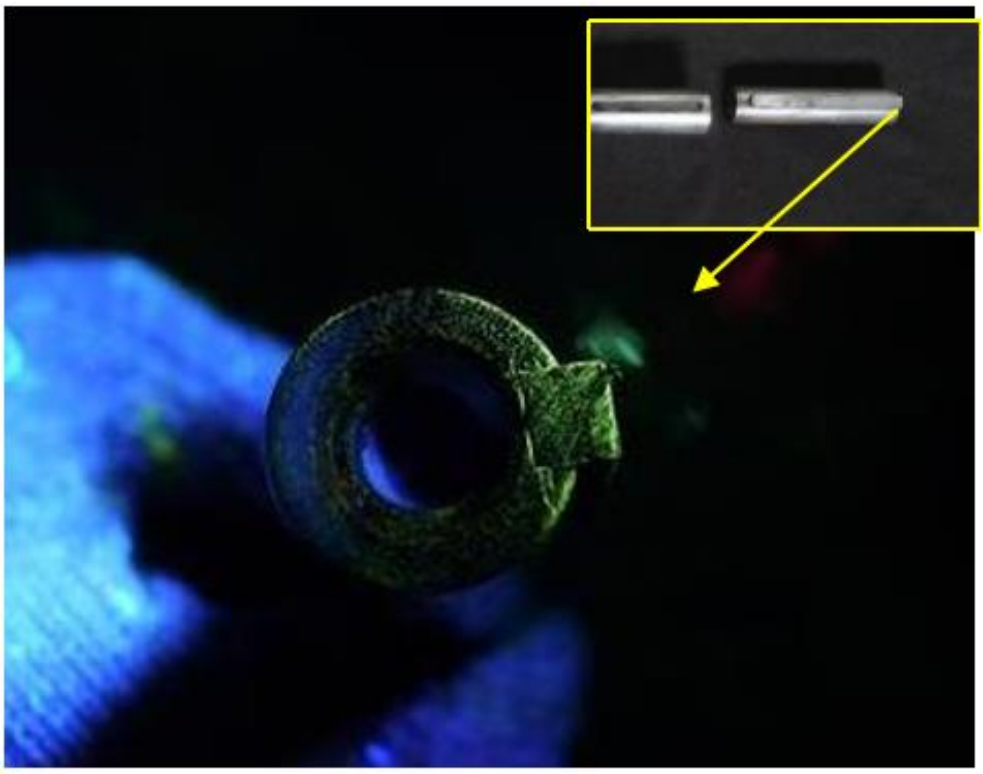
Plate: 4 The small surface plan view in WFMPI tested condition showing end opposite to the fracture surface. A linear indication seen at key way area

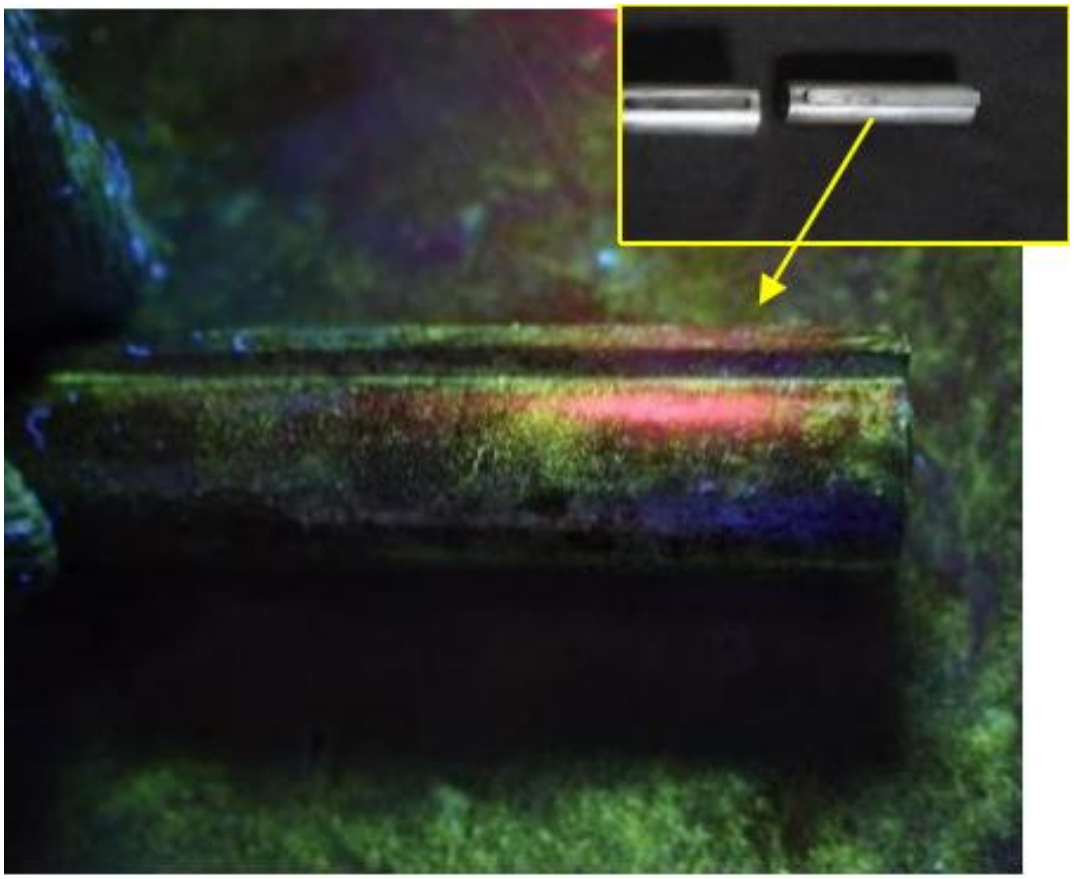
Plate: 5 Small shaft outer surface view surrounding the key way location. A tiny hairline crack like indication is seen on the surface.

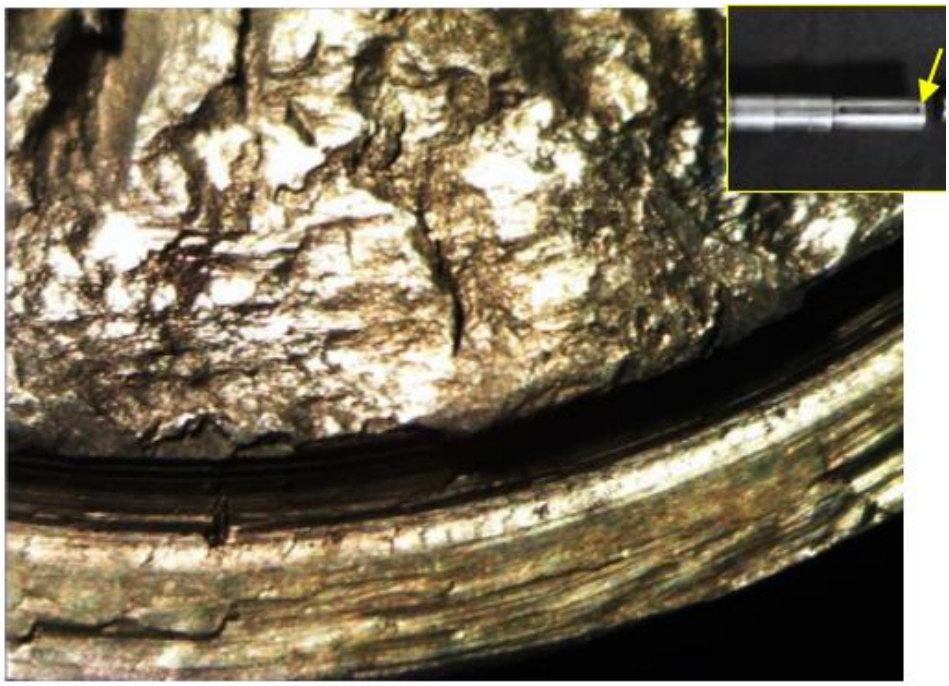
Plate: 7 Shows fracture surface low magnification view at the edges. The multiple ratchet marks are seen. Auxiliary cracking is also noticed. The rubbing is observed that seems to be post failure (10X)

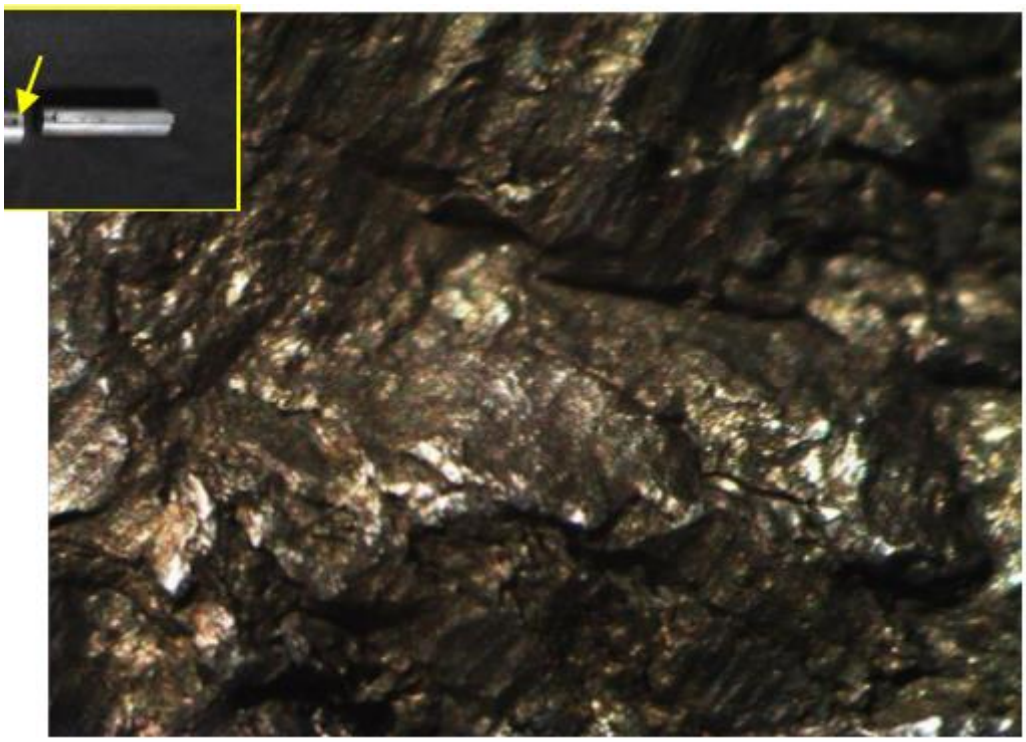
Plate: 8 Shows fracture surface low magnification view in the central portion. Petals of star pattern indicating torsional fatigue mode of failure are seen (20X)

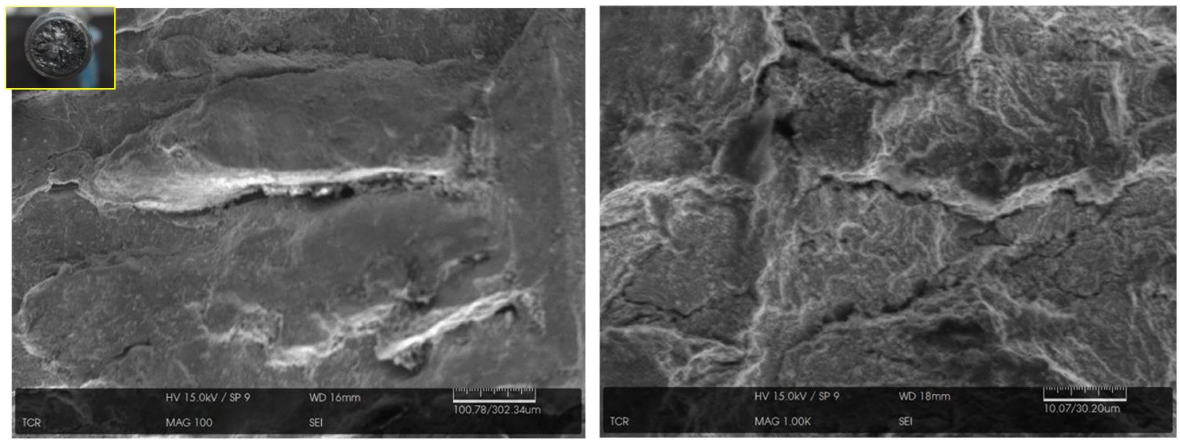
Plate: 9 Shows fracture surface view where petal like grooves indicative of starry fracture characteristic of torsional fatigue are seen. (100X)

Plate: 10 Shows core portion of fracture surface view with secondary cracks. (1000X)

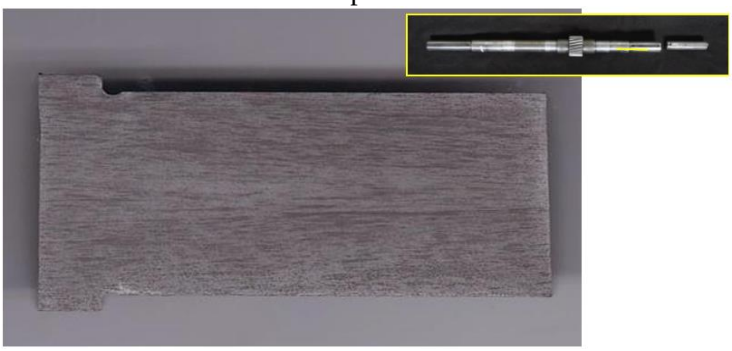
Plate: 11 Shows sample in macro etched condition. Normal grain flow is visible and it is free from any internal defects.

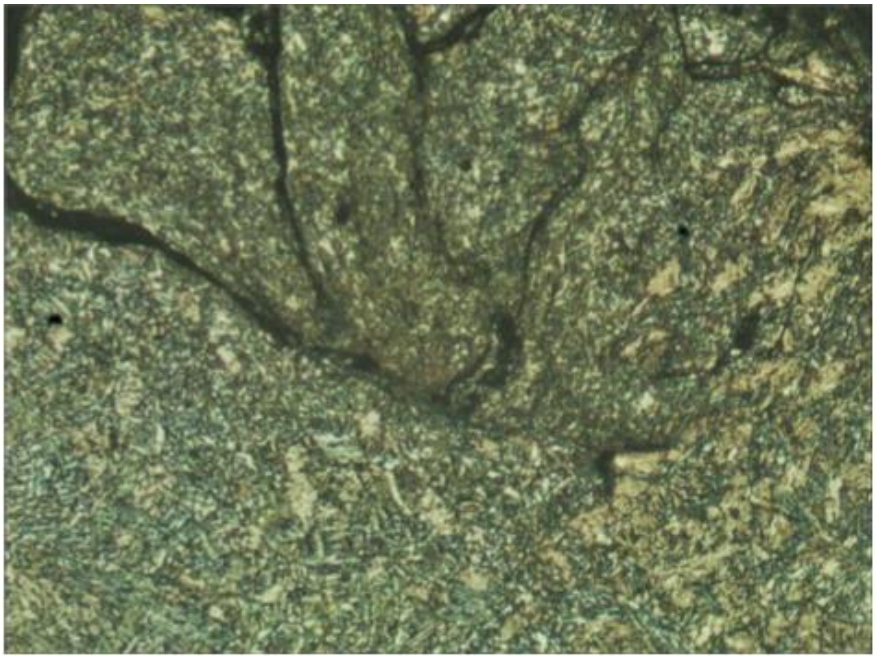
Plate: 12 Shows fracture edge microstructure of tempered martensite. Grains are slightly deformed at the edges. Crack network with uneven contours caused due to deformation is seen (200X)

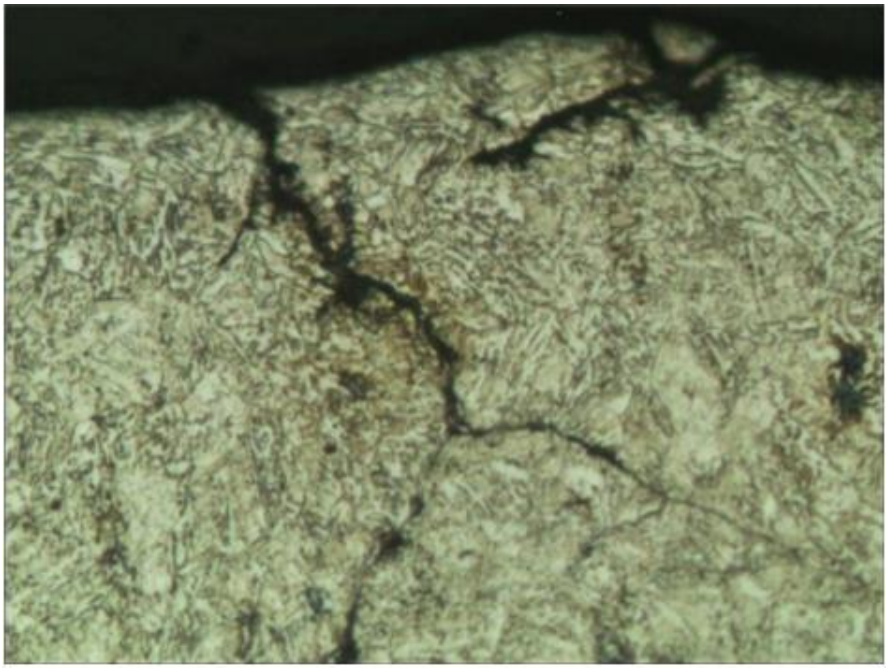
Plate: 13 Shows fracture edge microstructure of tempered martensite with ferrite traces. Transgranular cracking with fine tips and non-uniform contours are seen. (400X)

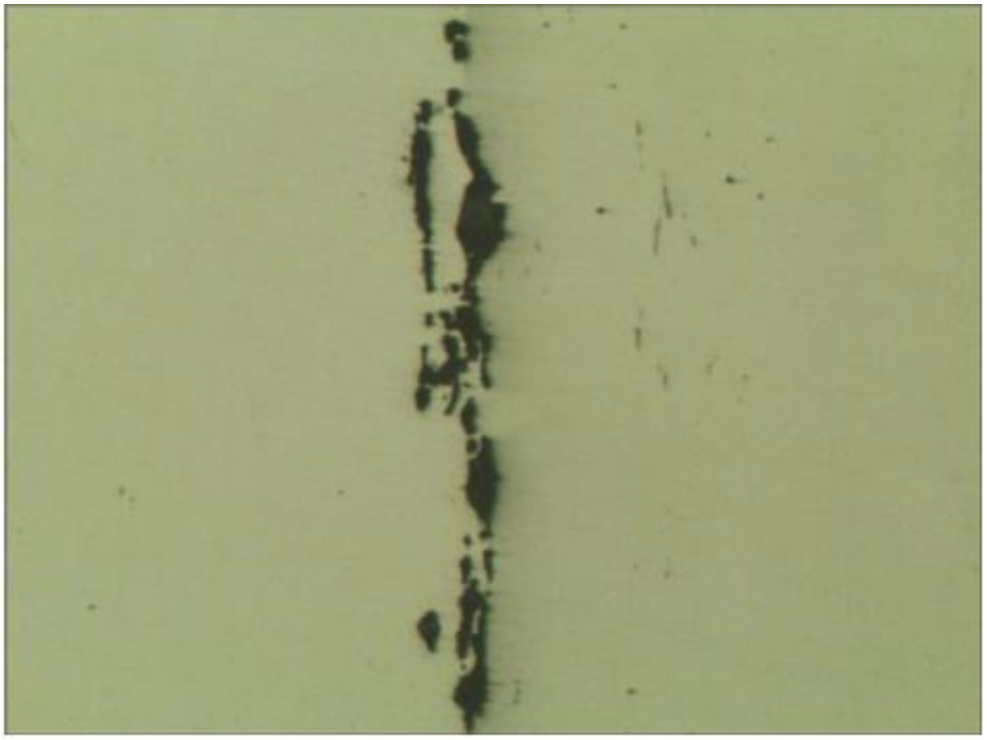
Plate: 14 As-polished view showing internal discontinuity which appears to be scale entrapment. (100X)

1. Reasons for jamming of the shaft during service required to be deliberated from the operation conditions.
2. The shaft quality needs to be improved from metallurgy point of view in terms of reduced inclusions and freedom from centre line discontinuity.
Design expert may be consulted for acceptance standard.

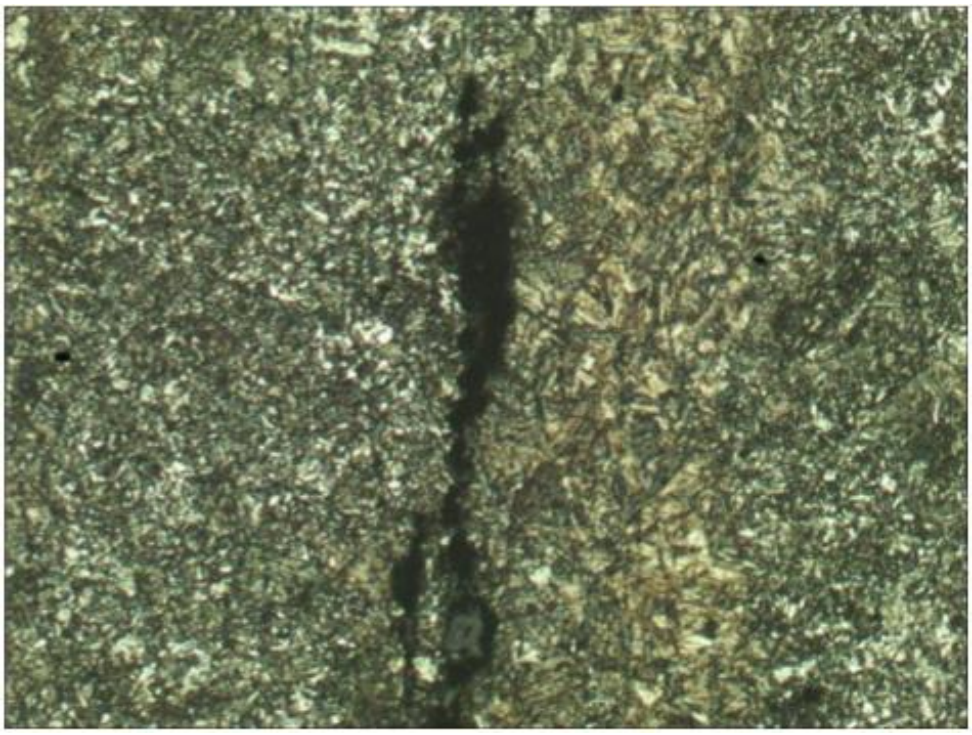
Plate: 15 Shows scale entrapment assuming the shape of crack with non uniform contours. Microstructure is tempered martensite with traces of ferrite. (200X)

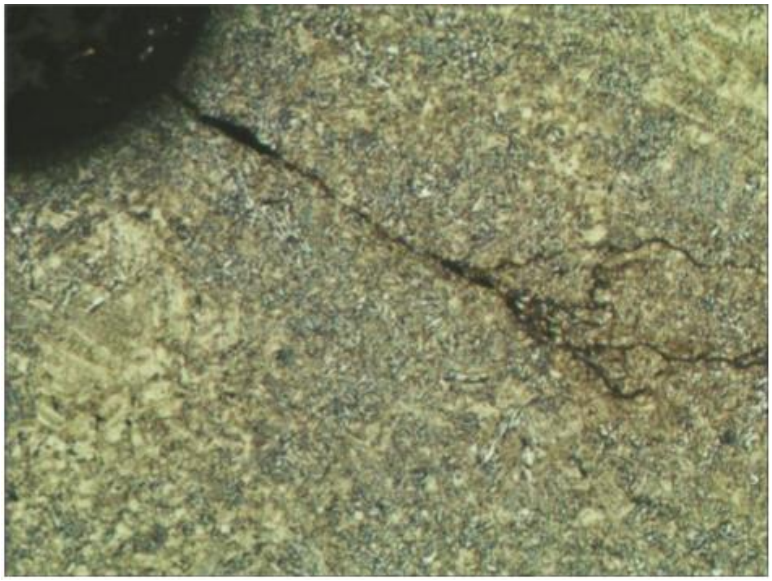
Plate: 16 Shows crack initiating from the keyway contour that has become branching in nature as it propagates. Microstructure is ferrite in traces and tempered martensite. (100X)

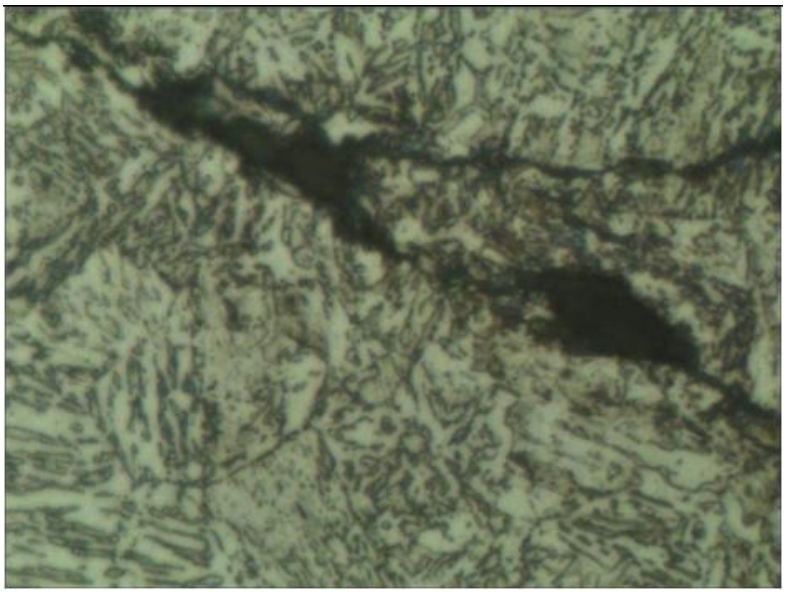
Plate: 17 Shows high magnification view at crack tip with branching tendency. Microstructure is ferrite traces and tempered martensite. (1000X)
